# Technical Bulletin #9

## CHIPPED TILE

January, 2000

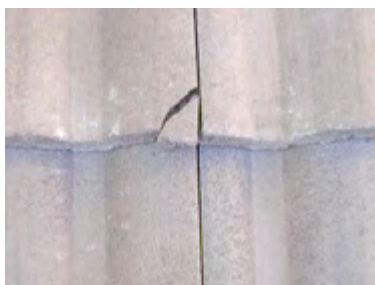
**Figure 1.** Broken cover lock corner

- If the cover lock corner is broken less than three inches, or less than the length of the headlap, and the broken piece is available, it may be possible to repair the corner by proper adhesive application. Using an adhesive specifically formulated for concrete roof tile, follow the manufacturer’s instructions to form a complete bond along the fracture. Take precautions not to allow excess adhesive to bond to the adjacent tile or create water blockage in the under lock.
